Materials Solutions for Hydrogen Delivery in Pipelines

Dr. Subodh K. Das SECAT Inc. 2006 DOE Hydrogen Project Review Arlington, VA 5/16/2006

Project ID # PDP 3

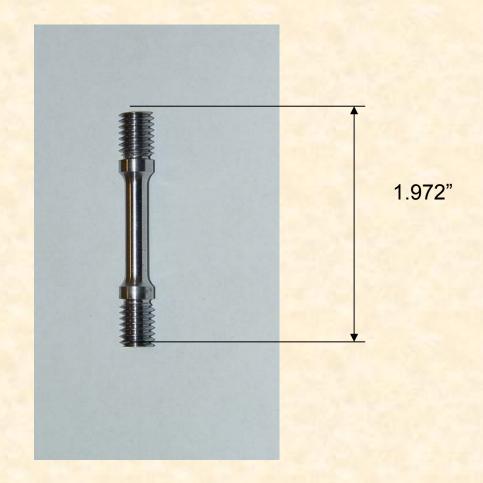
Technical Accomplishments/ Progress/Results - Specimens Have Been Prepared for Evaluation of Hydrogen Embrittlement with *ex-situ*

- Tensile specimens conforming to ASTM-E8 have been machined from three alloys, A, B, and C
- Baseline tests for mechanical properties were conducted at ORNL and ATC
- Samples were tested at Sandia National Laboratory, Livermore by Dr. Brian Somerday for their tendency for embrittlement using
 - Ex-situ high-pressure hydrogen charging, and
 - Tensile testing

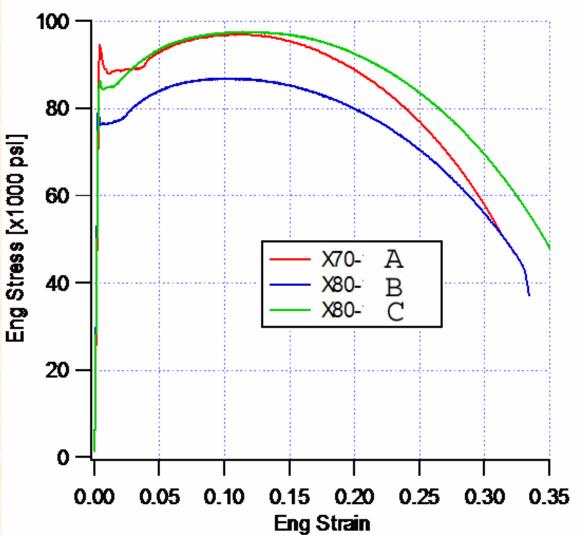
Technical Accomplishments/Progress/Results - Baseline Properties of Steels Obtained Using ASTM-E8 specimens

(No hydrogen)

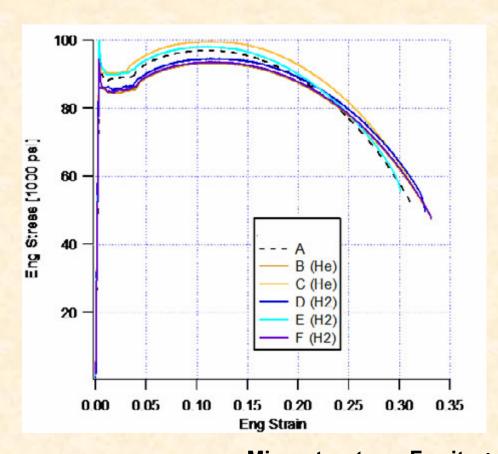
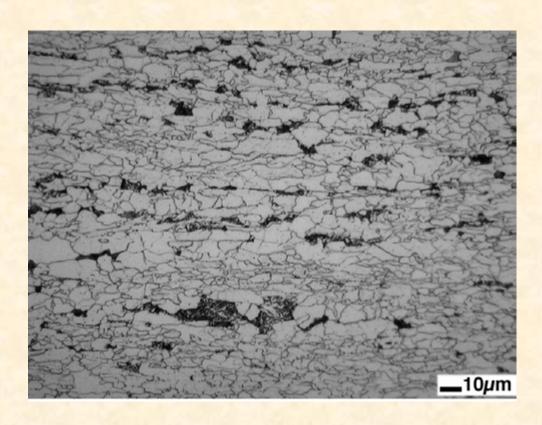
Technical Accomplishments/Progress/Results - Effect of Hydrogen on the Mechanical Properties of Steel A

Microstructure: Ferrite + Pearlite

Yield Stress: Intermediate

Note stress-strain curves variability

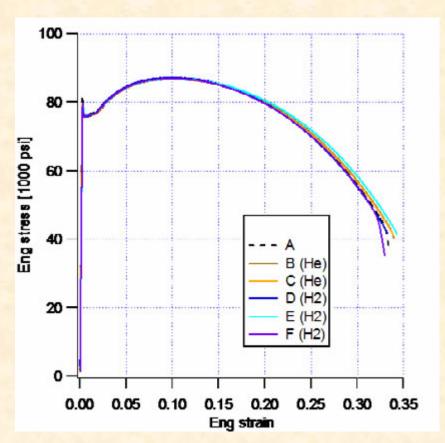
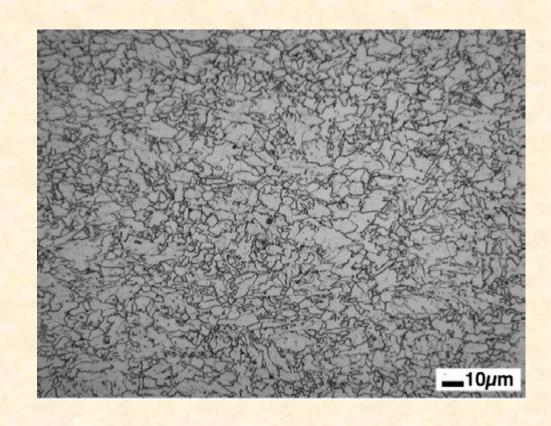
Technical Accomplishments/Progress/Results - Effect of Hydrogen on the Mechanical Properties of Steel B

Microstructure: Ferrite + Acicular Ferrite

Yield Stress: Low

Note consistent stress-strain curves

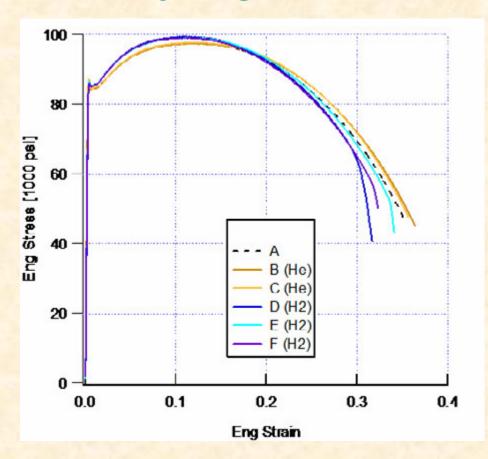
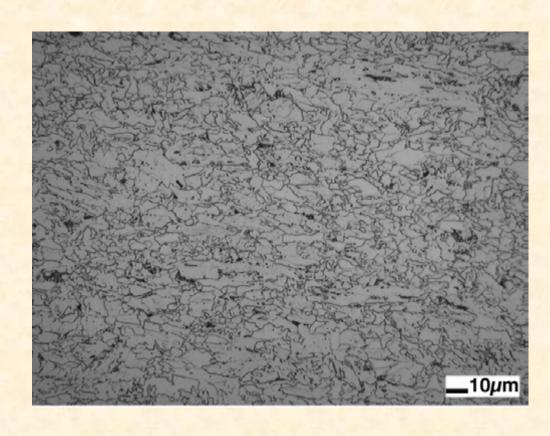
Technical Accomplishments/Progress/Results - Effect of Hydrogen on the Mechanical Properties of Steel C

Microstructure: Ferrite/acicular ferrite + small quantity pearlite

Yield Stress: High

Note stress-strain curve with slight variability

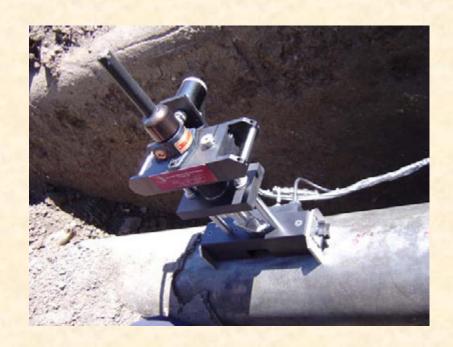
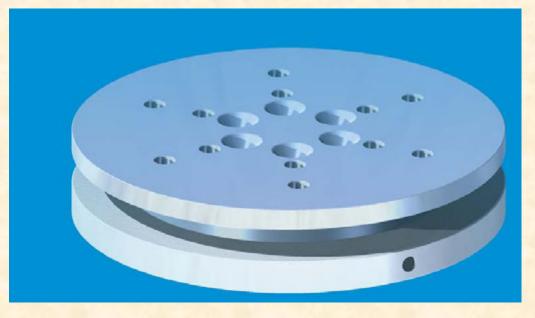
Technical Accomplishments/ Progress/Results - SSM Hydrogen Chamber (right photo) Allows conducting 5 ABI tests on each of six pipeline steel samples (1-inch diameter, 0.375-inch thick) at high hydrogen pressure and at various increasing exposure times using ATC's portable/In-situ SSM system (left photo).
